Sewer-Oscopy West LLC Randy Schad, Owner PO Box 1346 Templeton, CA 93465 (805) 769-6550 Seweroscopywest@gmail.com	Work Performed at: Sample address
Date:

YOUR SEWER INSPECTION REPORT

Prepared for: Customers Name
 Inspected by: Randy Schad (805) 769-6550
 Prepared on:

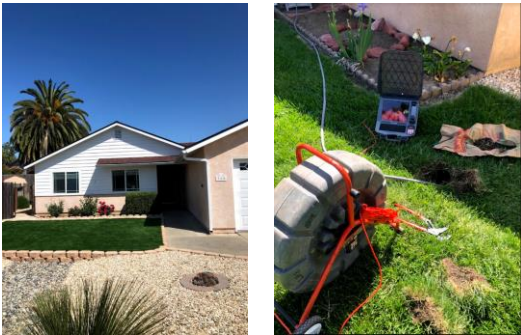
The 4" ABS clean-out was buried in the backyard. After searching, I was able to locate it to get in. I hit the main at 50' and started pulling back from that point. The lateral is 4" ABS into 4" PVC and is in good condition out to the main. Only recommendation is to make sure the clean-out is accessible in case any blockages happen in the future. Please let me know if you have any questions.
